**Flood Control Project Maintenance
Levee Inspections**

Maintenance Issue Types Only, Levee Inspection Report By Mile - Spring 2018

Reclamation District No. 1500 Sutter Basin

Waterway	Bank	Unit Miles	Inspection Start/End	Inspector
Unit No. 01 Sacramento River	Left	33.15	03/27/2018 03/28/2018	Zach Jojola

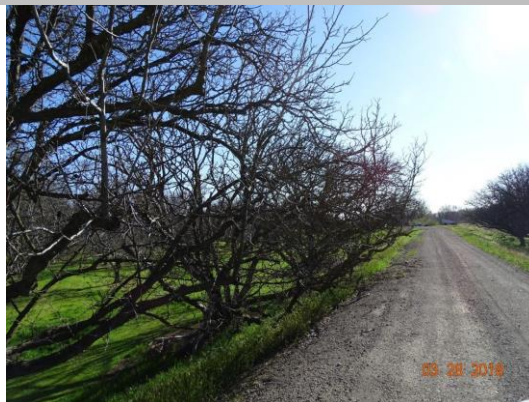
Photo 1 of 2 : SP_2018_RD1500_189_137_20180329_00241.jpg

LM Start	0.07	Rating **	M	Issue No.	137
LM End	0.07	Issue Type +	Ma	Location *	LS
Category	Earthen Levee		GPS Latitude/Longitude		
			Start	End	
Item	Trim / Thin Trees		38.761077 °	38.761077 °	
			-121.675851 °	-121.675851 °	
DWR ID	DWR_RD1500_01_f_2016_137				
Comment Code					
T1 : Trim trees to at least five feet above ground level.					
Inspector Comment					
Trim limbs on landside slope.

View of tree over the landside slope. Spring 2018.

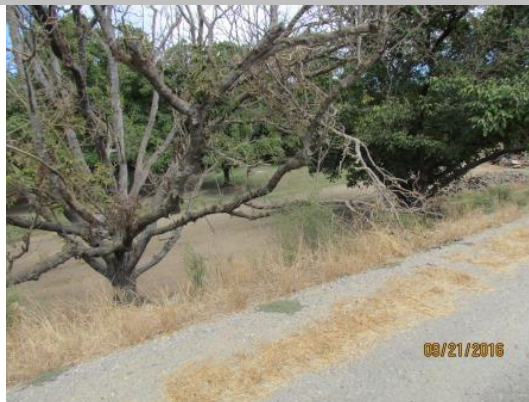
Photo 2 of 2 : SP_2018_RD1500_189_137_20180306_00072.jpg

LM Start	0.07	Rating **	M	Issue No.	137 (cont)
LM End	0.07	Issue Type +	Ma	Location *	LS

A tree on landside slope needs trimming. Fall 2016.

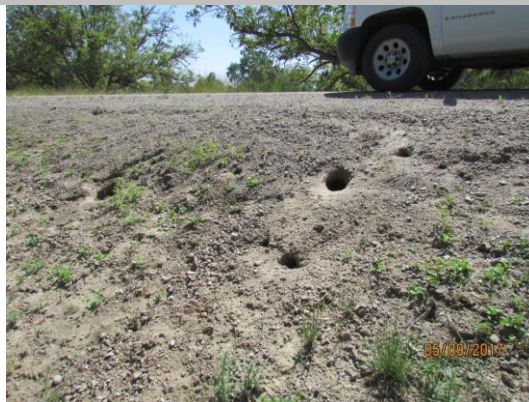
Photo 1 of 1 : SP_2018_RD1500_189_155_20180306_00079.jpg

View of rodent holes on landside slope. Spring 2017.

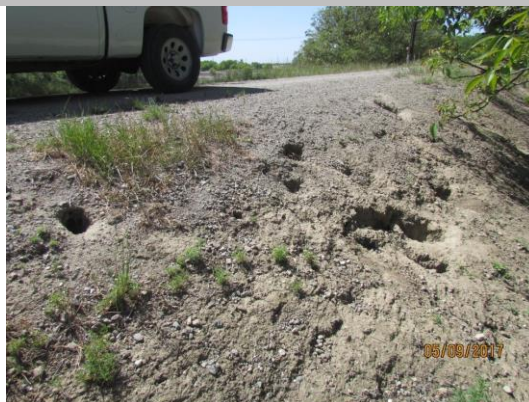
Photo 1 of 1 : SP_2018_RD1500_189_152_20180306_00078.jpg

LM Start	0.29	Rating **	M	Issue No.	152
LM End	0.29	Issue Type +	Ma	Location *	LS
Category	Earthen Levee			GPS Latitude/Longitude	
				Start	End
Item	Animal Control			38.762945 °	38.762945 °
				-121.678812 °	-121.678812 °
DWR ID	DWR_RD1500_01_f_2017_152				
Comment Code					
A3 : No rodents visible, but rodent burrows visible; need to backfill and compact or grout burrows.					
Inspector Comment

View of rodent holes on landside slope. Spring 2017.

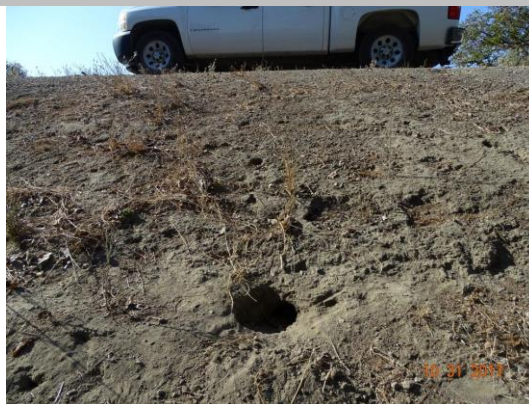
Photo 1 of 2 : SP_2018_RD1500_189_135_20180306_00070.jpg

Update view of hole on landside slope. Fall 2017.

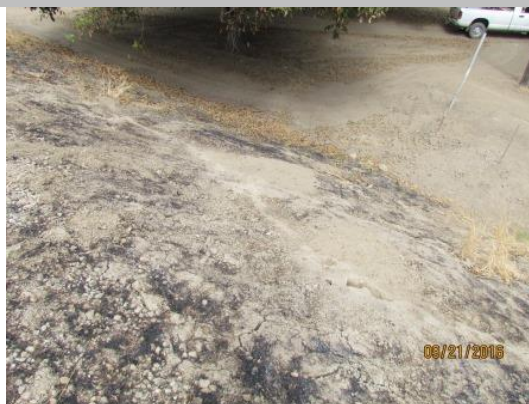
Photo 2 of 2 : SP_2018_RD1500_189_135_20180306_00071.jpg

LM Start	0.32	Rating **	M	Issue No.	135 (cont)
LM End	0.32	Issue Type +	Ma	Location *	LS

Rodent activity on LS slope. Fall 2016.

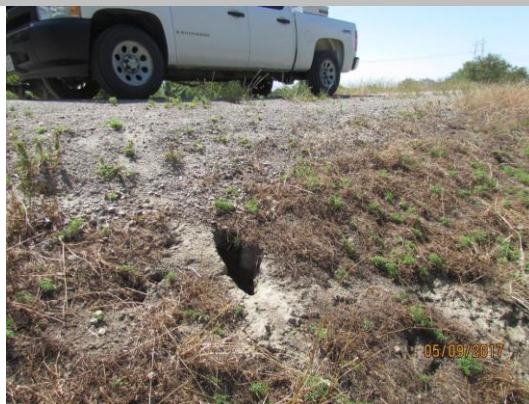
Photo 1 of 1 : SP_2018_RD1500_189_151_20180306_00077.jpg

LM Start	0.34	Rating **	M	Issue No.	151	
LM End	0.34	Issue Type +	Ma	Location *		
Category	Earthen Levee			GPS Latitude/Longitude		
				Start	End	
Item	Animal Control			38.763473 °	38.763473 °	
				-121.679300 °	-121.679300 °	
DWR ID	DWR_RD1500_01_s_2017_151					
Comment Code						
A3 : No rodents visible, but rodent burrows visible; need to backfill and compact or grout burrows.						
Inspector Comment

View of rodent holes on landside slope. Spring 2017.

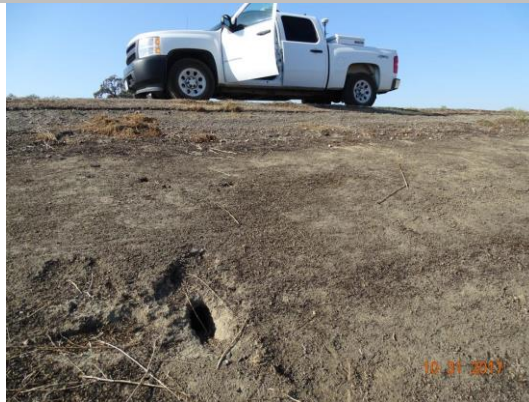
Photo 1 of 1 : SP_2018_RD1500_189_100_20180306_00051.jpg

LM Start	1.10	Rating **	M	Issue No.	100
LM End	1.10	Issue Type +	Ma	Location *	LS
Category	Earthen Levee			GPS Latitude/Longitude	
				Start	End
Item	Animal Control			38.767407 °	38.767407 °
				-121.691589 °	-121.691589 °
DWR ID	DWR_RD1500_01_s_2018_100				
Comment Code					
A3 : No rodents visible, but rodent burrows visible; need to backfill and compact or grout burrows.					
Inspector Comment					
Multiple holes on landside slope ad berm.

View of hole on landside slope. Fall 2017.

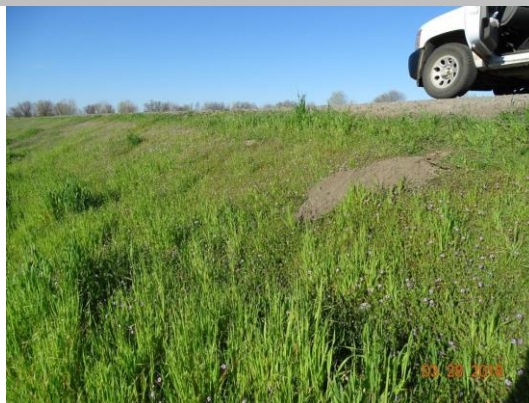
Photo 1 of 2 : SP_2018_RD1500_189_99_20180329_00240.jpg

Updated view of rodent holes. Spring 2018

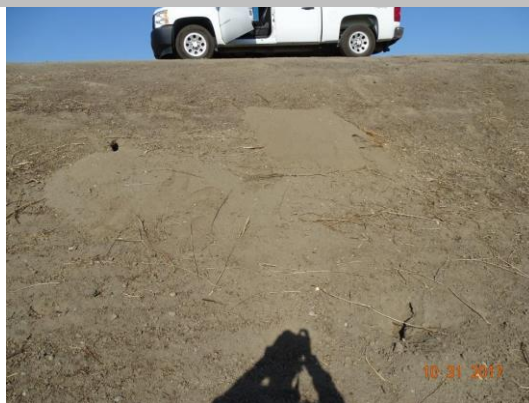
Photo 2 of 2 : SP_2018_RD1500_189_99_20180306_00050.jpg

View of holes and mounds on landside slope. Fall 2017.

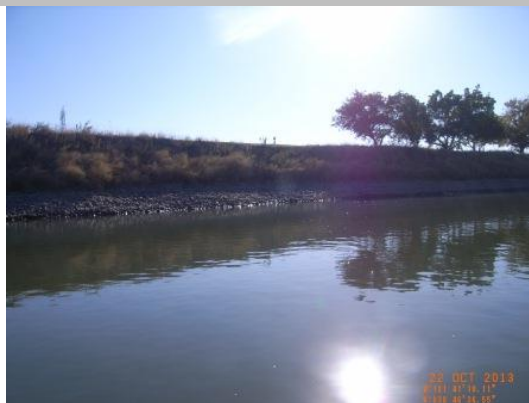
Photo 1 of 1 : SP_2018_RD1500_189_6_20180306_00006.jpg

LM Start	1.34	Rating **	A/W	Issue No.	6
LM End	1.95	Issue Type +	Ma	Location *	WS
Category	Supplemental			GPS Latitude/Longitude	
				Start	End
Item	2015 USACE Erosion Survey, DRAFT			38.770390 °	38.777282 °
				-121.690553 °	-121.685841 °
DWR ID	DWR_RD1500_01_s_2016_6				
Comment Code					
Inspector Comment					
2006 - New erosion upstream, new bank failures near levee but still fairly wide berm in most places. 2008 - Large berm, questionable as to if it should remain in the inventory. 2010 - Minor new erosion, old cobble starting to fail. 2011 - Cobble continues to unravel and additional slumping. 2012 - Minor new erosion at bank mid point. 2013 - Minor new erosion. 2015: No observed changes. [2015 Site ID: SAC_86-3_L]

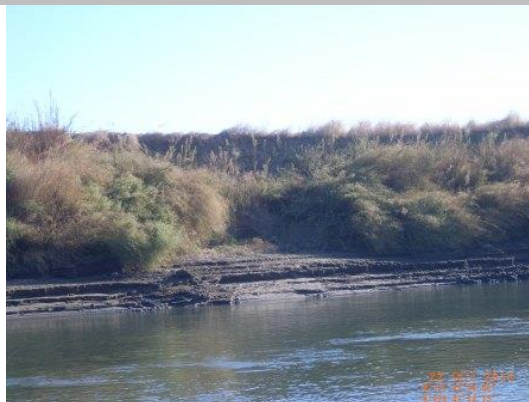
Photo 1 of 1 : SP_2018_RD1500_189_2_20180306_00002.jpg

LM Start	2.30	Rating **	A/W	Issue No.	2
LM End	2.52	Issue Type +	Ma	Location *	WS
Category	Supplemental			GPS Latitude/Longitude	
				Start	End
Item	2015 USACE Erosion Survey, DRAFT			38.781962 °	38.784936 °
				-121.688033 °	-121.690033 °
DWR ID	DWR_RD1500_01_s_2016_2				
Comment Code					
Inspector Comment					
2010 - The upstream end of the repair site at 87.0. Repair did not extend far enough upstream. 2011 - New erosion pockets. 2012 - Minor new erosion at toe. 2013 - Minor new erosion. 2015: Significant new toe erosion. [2015 Site ID: SAC_87-1_L]

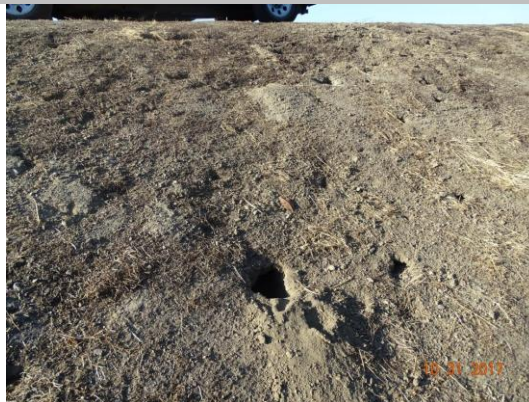
Photo 1 of 1 : SP_2018_RD1500_189_93_20180306_00047.jpg

LM Start	4.36	Rating **	A/W	Issue No.	93
LM End	4.36	Issue Type +	Ma	Location *	LS
Category	Earthen Levee			GPS Latitude/Longitude	
				Start	End
Item	Animal Control			38.803021 °	38.803021 °
				-121.698634 °	-121.698634 °
DWR ID	DWR_RD1500_01_f_2017_93				
Comment Code					
A3 : No rodents visible, but rodent burrows visible; need to backfill and compact or grout burrows.					
Inspector Comment					
Single hole less than 6" next to orchard found on landside slope. Recommend monitoring due to surrounding rodent activity.

View of hole on landside slope. Fall 2017.

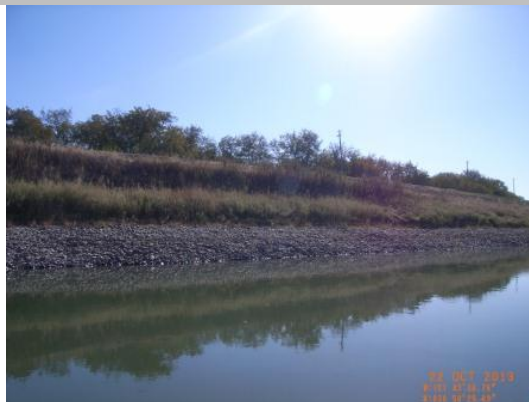
Photo 1 of 1 : SP_2018_RD1500_189_3_20180306_00003.jpg

LM Start	8.33	Rating **	A/W	Issue No.	3
LM End	8.47	Issue Type +	Ma	Location *	WS
Category	Supplemental			GPS Latitude/Longitude	
				Start	End
Item	2015 USACE Erosion Survey, DRAFT			38.839546 °	38.840347 °
				-121.729591 °	-121.726857 °
DWR ID	DWR_RD1500_01_s_2016_3				
Comment Code					
Inspector Comment					
1997 - Damage to cobble revetment on top left bank and toe damage. 2004 - Site is pretty minor. 2010 - Cobbles continue to deteriorate. 2011 - Minor new erosion at the toe. 2013 - Might be able to shorten due to deposition. 2015: Site shortened, downstream end has plenty of berm and deposited material, well vegetated. [2015 Site ID: SAC_92-8_L]

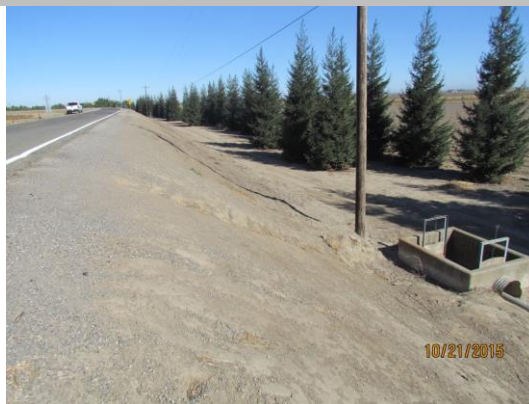
Photo 1 of 3 : SP_2018_RD1500_189_114_20180306_00058.jpg

LM Start	11.45	Rating **	A/W	Issue No.	114
LM End	11.45	Issue Type +	Ma	Location *	LS
Category	Earthen Levee			GPS Latitude/Longitude	
				Start	End
Item	Slope Stability			38.868577 °	38.868577 °
				-121.746487 °	-121.746487 °
DWR ID	DWR_RD1500_01_f_2015_114				
Comment Code					
S2 : Repair the levee slope damaged by foot traffic and prevent access where possible.					
Inspector Comment					
The previous stairs in the photos have been filled in, but the slope remains an active access ramp. Recommend monitoring.

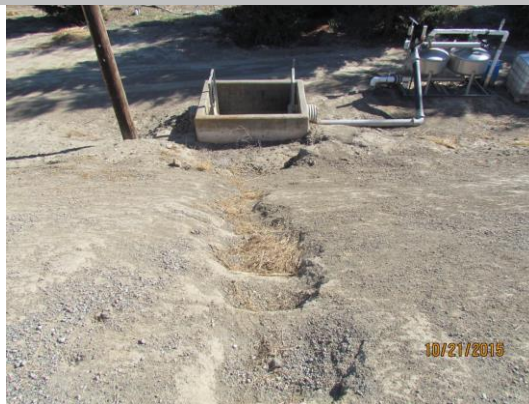
Photo 2 of 3 : SP_2018_RD1500_189_114_20180306_00059.jpg

There is erosion at the levee toe around the concrete box. There are also stairs leading down the slope. Fall 2015.

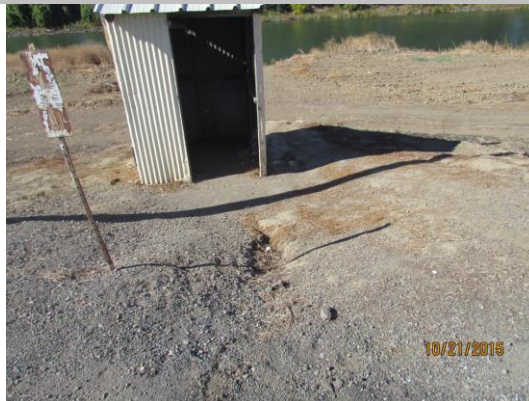
Photo 3 of 3 : SP_2018_RD1500_189_114_20180306_00060.jpg

LM Start	11.45	Rating **	A/W	Issue No.	114 (cont)	
LM End	11.45	Issue Type +	Ma	Location *	LS	
Category	Earthen Levee			GPS Latitude/Longitude		
				Start		End
Item	Slope Stability			38.868577 °		38.868577 °
				-121.746487 °		-121.746487 °
DWR ID	DWR_RD1500_01_f_2015_114					
Comment Code						
S2 : Repair the levee slope damaged by foot traffic and prevent access where possible.						
Inspector Comment						
The previous stairs in the photos have been filled in, but the slope remains an active access ramp. Recommend monitoring.

There is slight erosion on the waterward side of the levee where the pipe seems to run through the levee. Fall 2015.

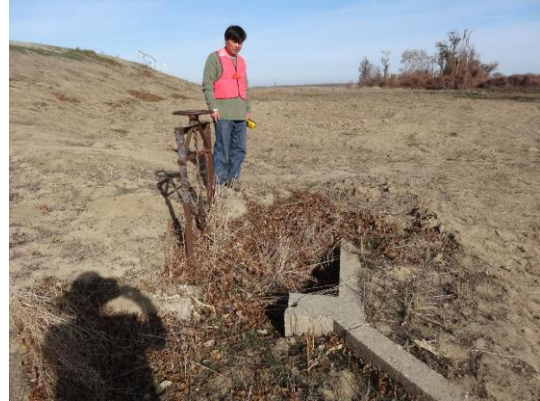
Photo 1 of 3 : UCIP_SP_2018_50197_52425.jpg

FS_ID:50197
DS_ID:20063
EP_NO: 10061
Repair Type: Non-Urgent
Crossing Status: Found
UCIP Comments: 08/29/2016 Same as last inspection. (K. Fazel - UCIP)01/10/2014 Needs proper abandonment. (P. Amatya - DWR)
FIELD_STRUCT_DESC: *ABANDONED* 18-inch corrugated metal gravity drainage pipe through the levee, 15 feet below the crown. Slide gate in a 4-foot by 4-foot concrete box at the waterside (WS) toe. Concrete box at the landside (LS) toe. Pipe crosses overflow area to the river. Installed by USACE in 1944. (18-inch corrugated metal gravity drainage pipe through the levee and all other appurtenances retained under Automatic Board Order (ABO) issued as Permit No. 10061, 1974 - Roger L. Matteoli). [Additional Reference(s): DWR Levee Log, 2005. USACE Sacramento O&M Manual 128, March 1960, (HLM 12.69)].
FS Date: 8/29/2016

WS view: slide gate (left) in concrete box at levee toe. Slide gate and the box mostly buried.

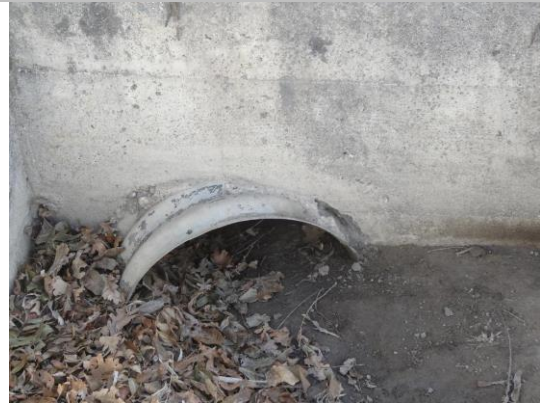
Photo 3 of 3 : UCIP_SP_2018_50197_52423.jpg

Item	DWR UCIP LMA Responsibility			38.867254 °	38.867254 °	
				-121.761212 °	-121.761212 °	
DWR ID						
Comment Code						
Inspector Comment						
FS_ID:50197 DS_ID:20063 EP_NO: 10061 Repair Type: Non-Urgent Crossing Status: Found UCIP Comments: 08/29/2016 Same as last inspection. (K. Fazel - UCIP)01/10/2014 Needs proper abandonment. (P. Amatya - DWR) FIELD_STRUCT_DESC: *ABANDONED* 18-inch corrugated metal gravity drainage pipe through the levee, 15 feet below the crown. Slide gate in a 4-foot by 4-foot concrete box at the waterside (WS) toe. Concrete box at the landside (LS) toe. Pipe crosses overflow area to the river. Installed by USACE in 1944. (18-inch corrugated metal gravity drainage pipe through the levee and all other appurtenances retained under Automatic Board Order (ABO) issued as Permit No. 10061, 1974 - Roger L. Matteoli). [Additional Reference(s): DWR Levee Log, 2005. USACE Sacramento O&M Manual 128, March 1960, (HLM 12.69)]. FS Date: 8/29/2016

LS view: silted CMP in concrete intake box on levee toe.

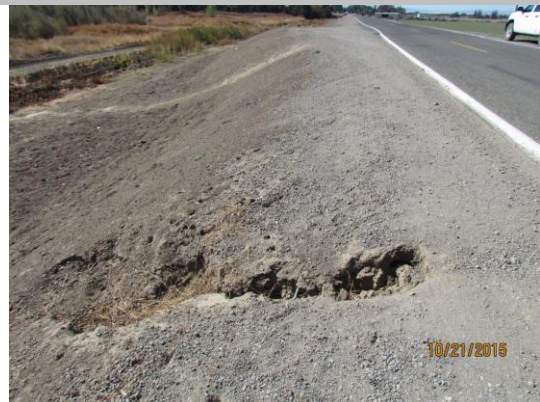
Photo 1 of 1 : SP_2018_RD1500_189_118_20180306_00063.jpg

LM Start	12.57	Rating **	M	Issue No.	118
LM End	12.57	Issue Type +	Ma	Location *	WS
Category	Earthen Levee			GPS Latitude/Longitude	
				Start	End
Item	Erosion / Bank Caving			38.867108 °	38.867108 °
				-121.761498 °	-121.761498 °
DWR ID	DWR_RD1500_01_f_2015_118				
Comment Code					
E2 : Schedule repair of erosion site prior to the next inspection.					
Inspector Comment

View of the erosion on the waterward side of the levee looking upstream. Fall 2015.

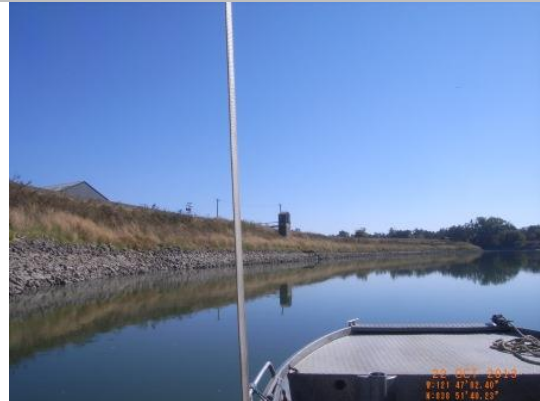
Photo 1 of 1 : SP_2018_RD1500_189_10_20180306_00011.jpg

LM Start	13.98	Rating **	A/W	Issue No.	10
LM End	14.26	Issue Type +	Ma	Location *	WS
Category	Supplemental			GPS Latitude/Longitude	
				Start	End
Item	2015 USACE Erosion Survey, DRAFT			38.857239 °	38.861899 °
				-121.783771 °	-121.784057 °
DWR ID	DWR_RD1500_01_s_2016_10				
Comment Code					
Inspector Comment					
1997 - Intermittent toe failure of the hand placed riprap; failure of toe materials. 2015: No observed changes. [2015 Site ID: SAC_99-0_L]

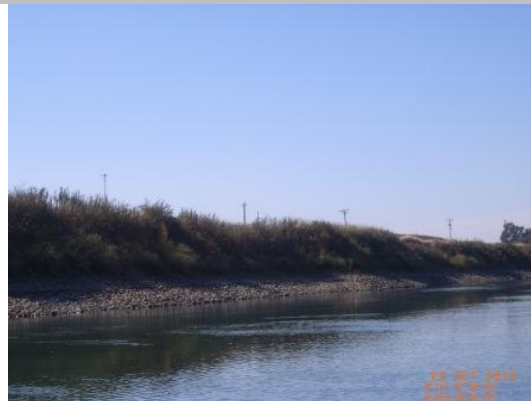
Photo 1 of 1 : SP_2018_RD1500_189_13_20180306_00013.jpg

LM Start	18.38	Rating **	A/W	Issue No.	13
LM End	19.06	Issue Type +	Ma	Location *	WS
Category	Supplemental			GPS Latitude/Longitude	
				Start	End
Item	2015 USACE Erosion Survey, DRAFT			38.901337 °	38.902721 °
				-121.801175 °	-121.790677 °
DWR ID	DWR_RD1500_01_s_2016_13				
Comment Code					
Inspector Comment					
1997 - Pocket failures of cobble revetment toe; scallops of rock loss along the bank; irregular bankline developing. 2001 - Small scallops in the toe of the berm. 2005 - Still multiple erosion pockets in the toe. 2006 - Two new small slumps. 2011 - Old cobble continue to fail causing minor slumping. 2012 - Portions of site appears to be stabilizing. 2015: No observed changes. [2015 Site ID: SAC_104-0_L]

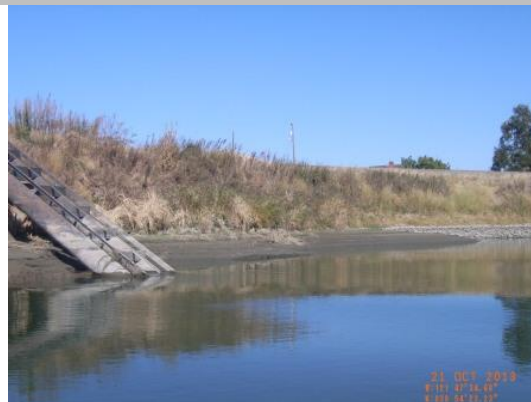
Photo 1 of 1 : SP_2018_RD1500_189_5_20180306_00005.jpg

LM Start	19.16	Rating **	A/W	Issue No.	5
LM End	19.47	Issue Type +	Ma	Location *	WS
Category	Supplemental			GPS Latitude/Longitude	
				Start	End
Item	2015 USACE Erosion Survey, DRAFT			38.904041 °	38.906697 °
				-121.790298 °	-121.792796 °
DWR ID	DWR_RD1500_01_s_2016_5				
Comment Code					
Inspector Comment					
1997 - Cobbles eroded off the clay materials; not much evidence of erosion on the toe; cobble loss on the toe. 2011 - Some minor new erosion. 2015: No observed changes. [2015 Site ID: SAC_104-5_L]

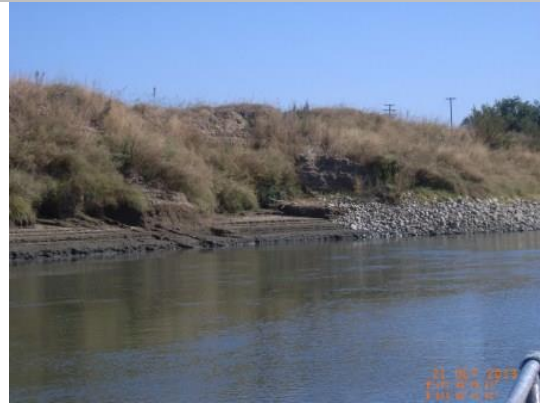
Photo 1 of 1 : SP_2018_RD1500_189_15_20180306_00014.jpg

Comment Code					
Inspector Comment					
2003 - New sedimentation and some new small toe scallops at the upstream end; downstream end has some new erosion. 2004 - Some new erosion at the toe and upper bank and some small new rotational failures (mainly minor, except at the downstream end). 2007 - Some new slumps. 2009 - Some new scallops and site was extended upstream. 2010 - New deposition along upstream end of site, however there is also new erosion throughout the site. Site seems to be worsening, and eroding fast. Large habitat for bank swallows. 2011 - Some new minor erosion. 2012 - Minor new erosion. 2015: No observed changes. [2015 Site ID: SAC_116-5_L]

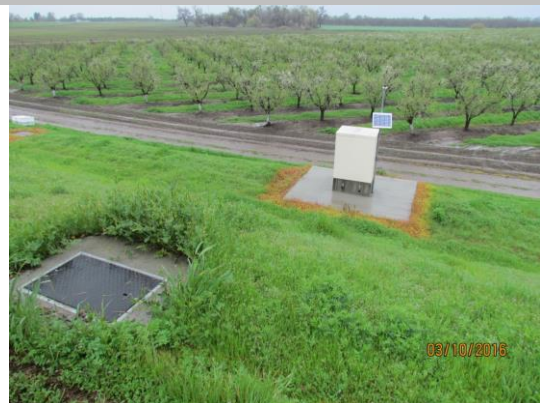
Photo 1 of 2 : SP_2018_RD1500_189_86_20180306_00045.jpg

LM Start	31.54	Rating **	A/W	Issue No.	86
LM End	31.54	Issue Type +	Ma	Location *	LS
Category	Earthen Levee			GPS Latitude/Longitude	
				Start	End
Item	Encroachments			39.006687 °	39.006687 °
				-121.814967 °	-121.814967 °
DWR ID	DWR_RD1500_01_s_2016_86				
Comment Code					
MW : Monitoring Well					
Inspector Comment					
UCIP installed this monitoring station for seepage in the area. Monitor for vandilism or damagePN: (18630).

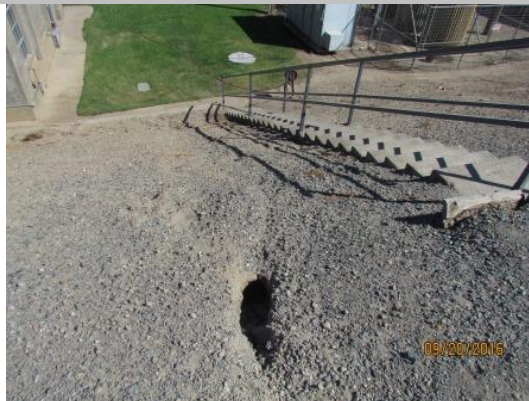
Photo 1 of 1 : SP_2018_RD1500_189_107_20180306_00054.jpg

View of rodent burrows on landside slope. Fall 2016.

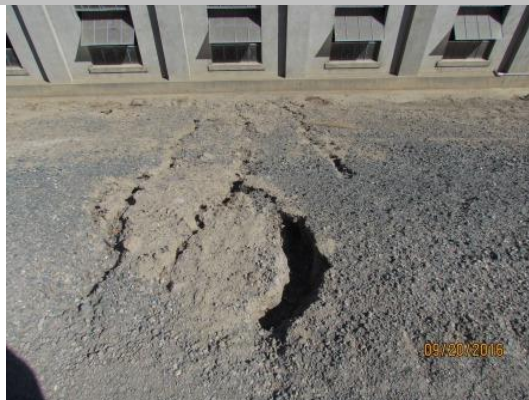
Photo 1 of 1 : SP_2018_RD1500_189_106_20180306_00053.jpg

View of erosion site on LS slope of the levee. Fall 2016.

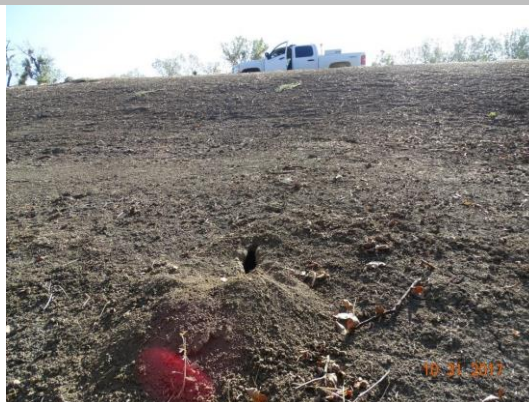
Photo 1 of 1 : SP_2018_RD1500_190_39_20180306_00010.jpg

View of rodent hole on landside slope. Fall 2017.
